ELS continuously evolves its airport maintenance activities to progress our programs ahead of industry standards. One example of our value added services has been achieved through Reliability Centered Maintenance (RCM) techniques. This approach leans heavily on predictive maintenance inspections rather than reactive “break-fix” and is used in conjunction with traditional preventive maintenance scheduling. This process has been in place at our long running Baggage Handling System (BHS) programs and has been instrumental in keeping BHS availability consistently greater than 95%.

## SPOTLIGHT:

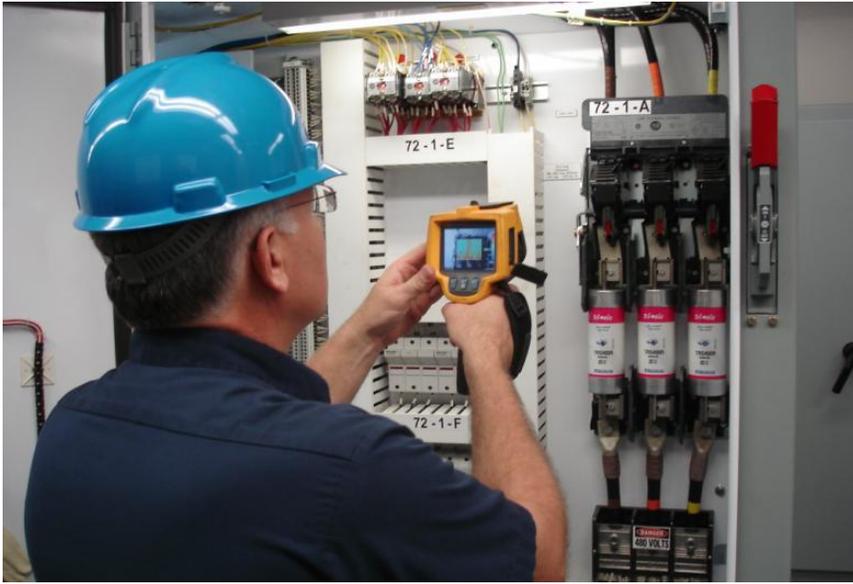
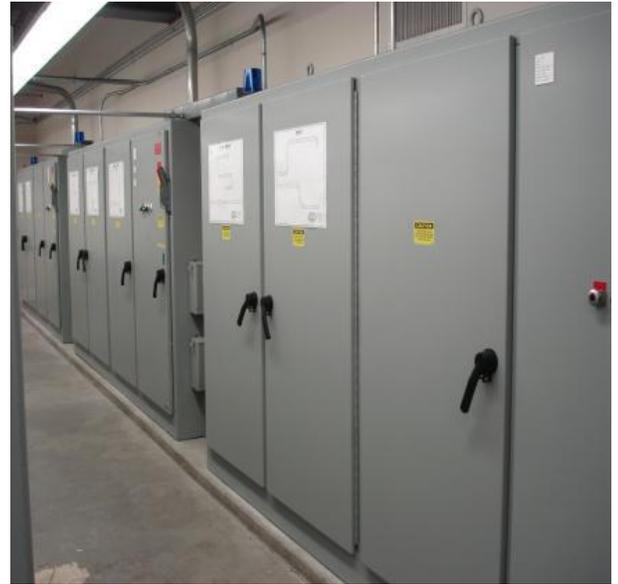
For example the photograph above left demonstrates a main disconnect switch which when viewed with the IR camera demonstrated a significant rise in temperature compared to those positioned either side. External inspection did not provide any indication of a problem, however when the switch was removed it had evidence of heat distress and carbon build up on its surfaces (right). Although it had not resulted in a failure at that time, a work order was raised, parts were removed from inventory and the repair was scheduled to be performed to cause the least disruption to BHS operations. Upon the replacement, the new switch was checked with the IR camera which confirmed that the issue had been rectified.

**How does this IR system work?** When establishing a predictive inspection plan using an IR camera, shots are taken of each set of electrical components which are then filed in their sequence order using a pre-established inspection route. Initial images are used to create the components heat signature base line against which future images will be compared. The camera software will also help distinguish between real problems and false alarms.
